CVRI – EPO 2013 / CR-34

OBED MOUNTAIN MINE

REMEDIATION DESIGN – BI-WEEKLY UPDATE REPORT

AUGUST 10 – AUGUST 22, 2018

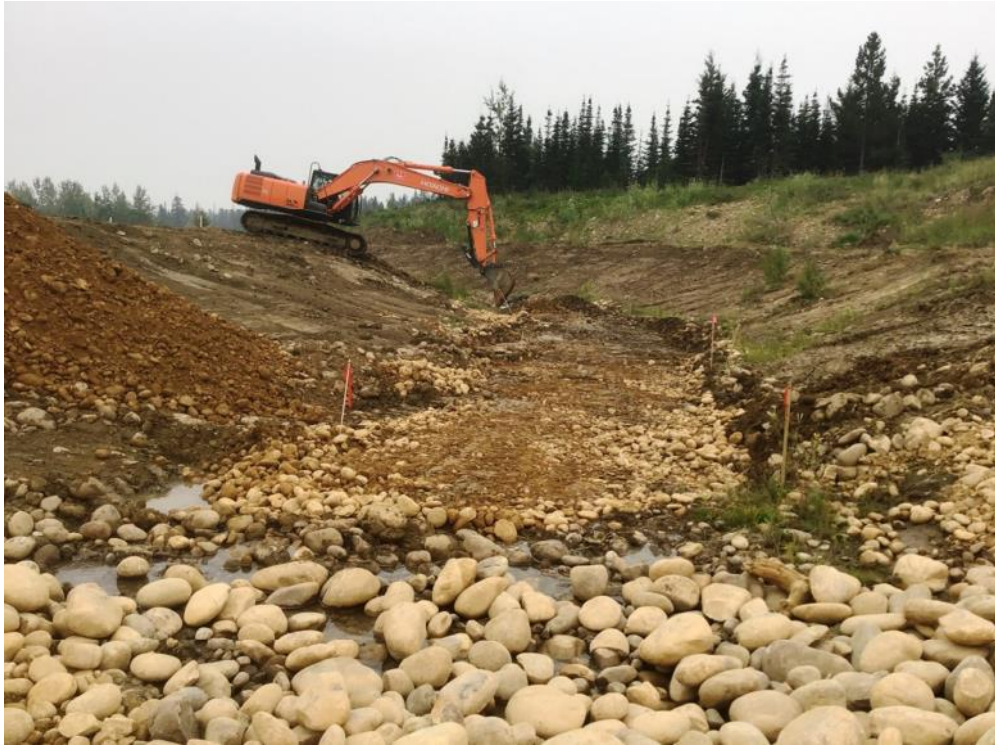
August 14, 2018: Looking downstream at channel shaping from 0+250 to 0+290 and pitrun gravel placement on channel bed from about 0+240 to 0+270.

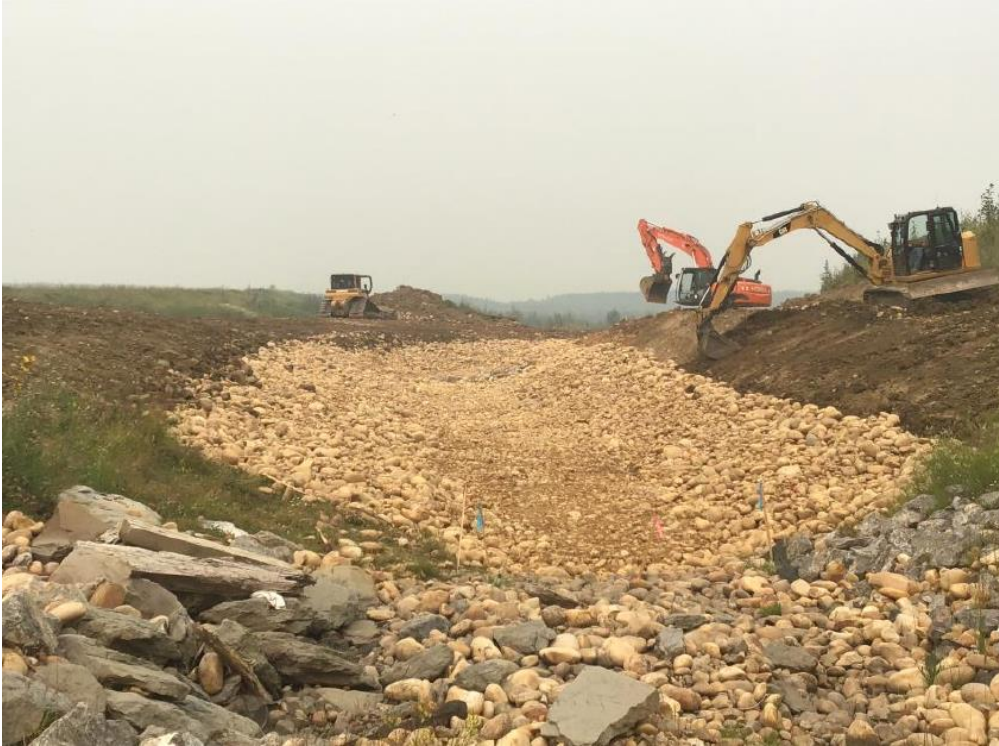
August 15, 2018: Looking downstream from 0+060 at channel shaping above the Class 1 rounded in preparation of topsoil placement and seeding/planting. Fines on the channel surface will be flushed using pumped water.

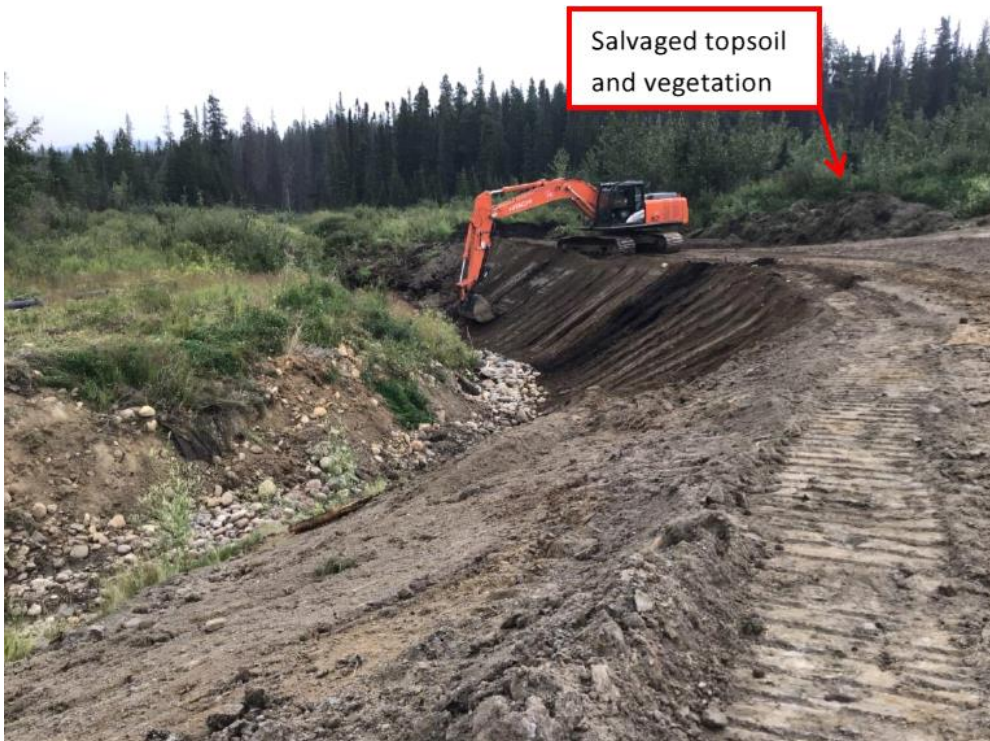
August 17, 2018: Looking downstream from 0+360 at shaping of right overbank.

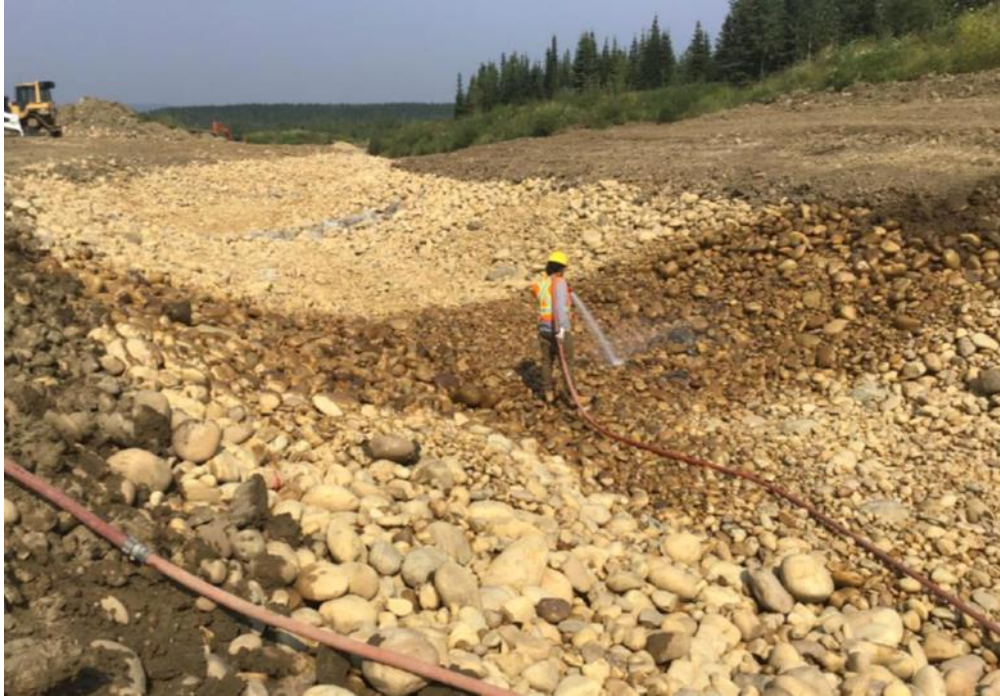
- Fines in APC-1 were flushed via a pump and hose; fines were forced down into the riprap voids keeping the gravels near the surface
- The natural channel design will start at about 0+350; this starting location will provide about 50 m more natural channel length compared to the design (Drawing 102); this field layout change reduces the number of rocks required (and amount of angular riprap imported to site from Nordegg; more earthworks were required to construct the floodplain at the natural channel section; the equipment Rocko's has on site is well-suited for these earthworks

August 18, 2018: Looking downstream from 0+080 at APC-1 flushing using hose connected to trash pump.

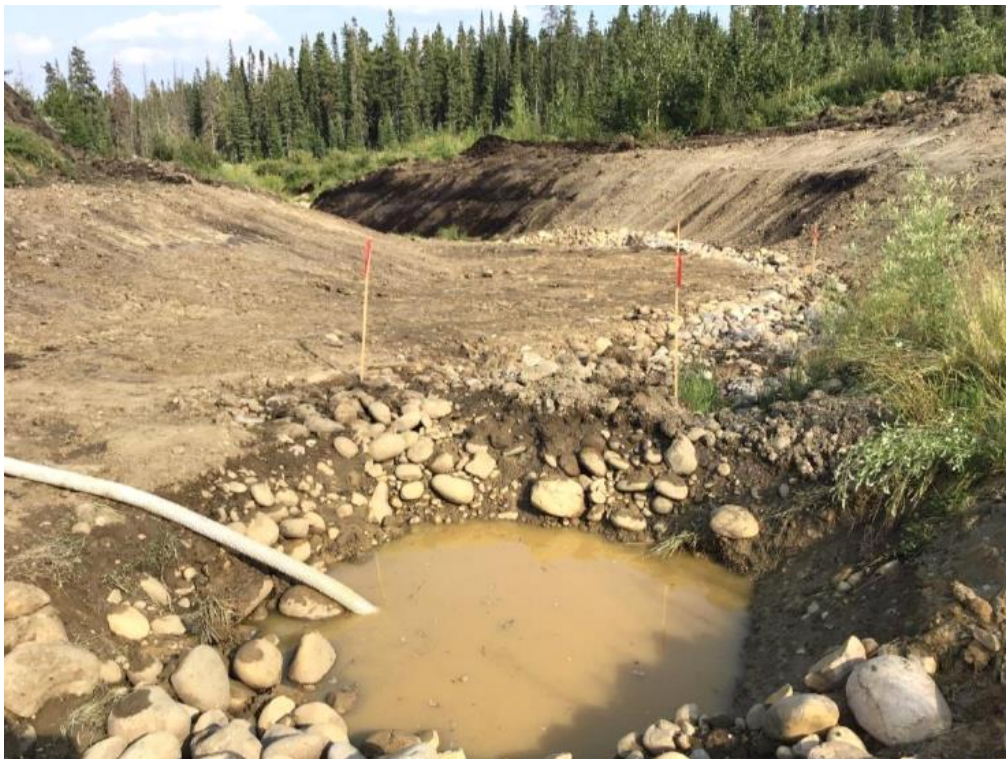
August 19, 2018: Looking downstream from 0+360 at constructed floodplain excavation for natural channel design. The natural channel design will start at about 0+350. This starting location will provide an extra 50 m of natural channel compared to design (sump in foreground; water from sump is being pumped to well vegetated areas away from the natural watercourse).
