EPO 2013/ CR-34
Obed Mountain Mine
Monthly Status Report – June 2018

Issued: July 6, 2018

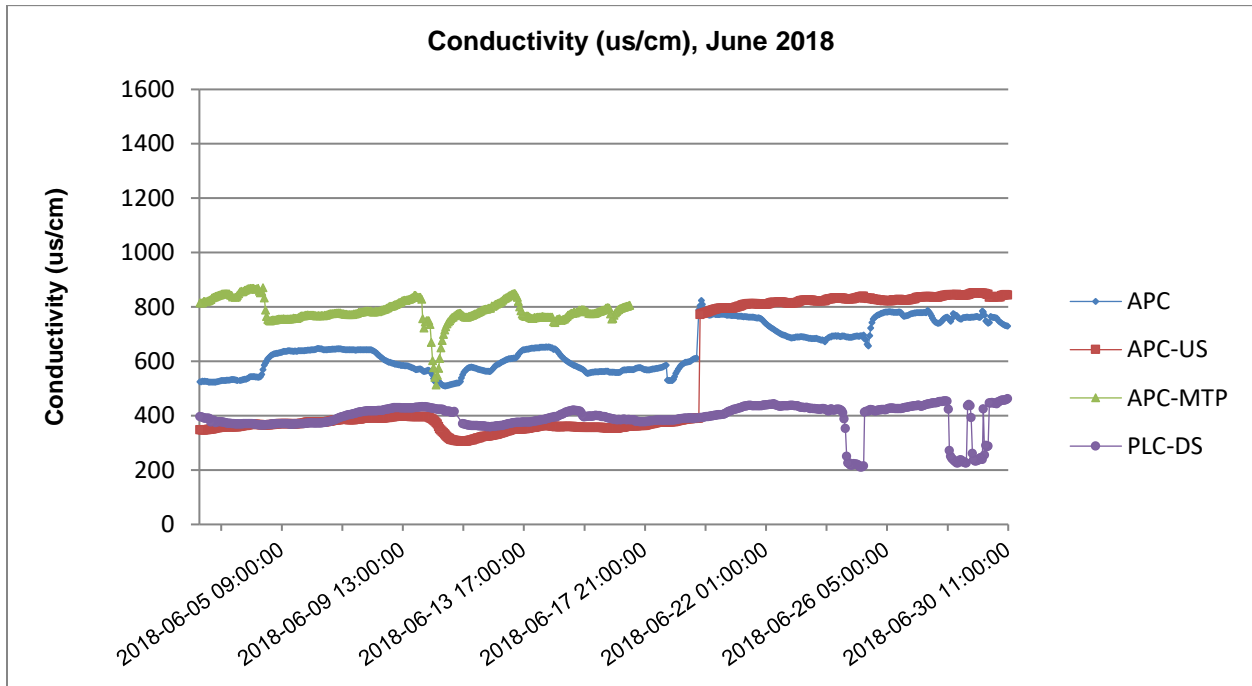
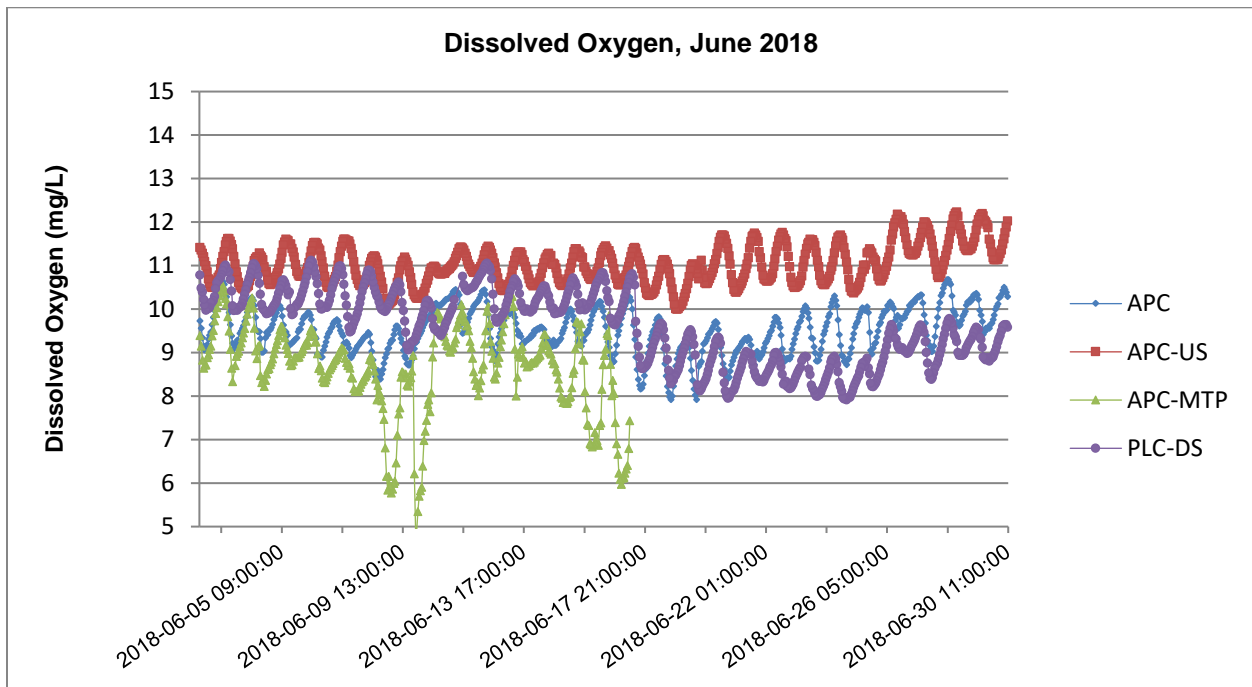
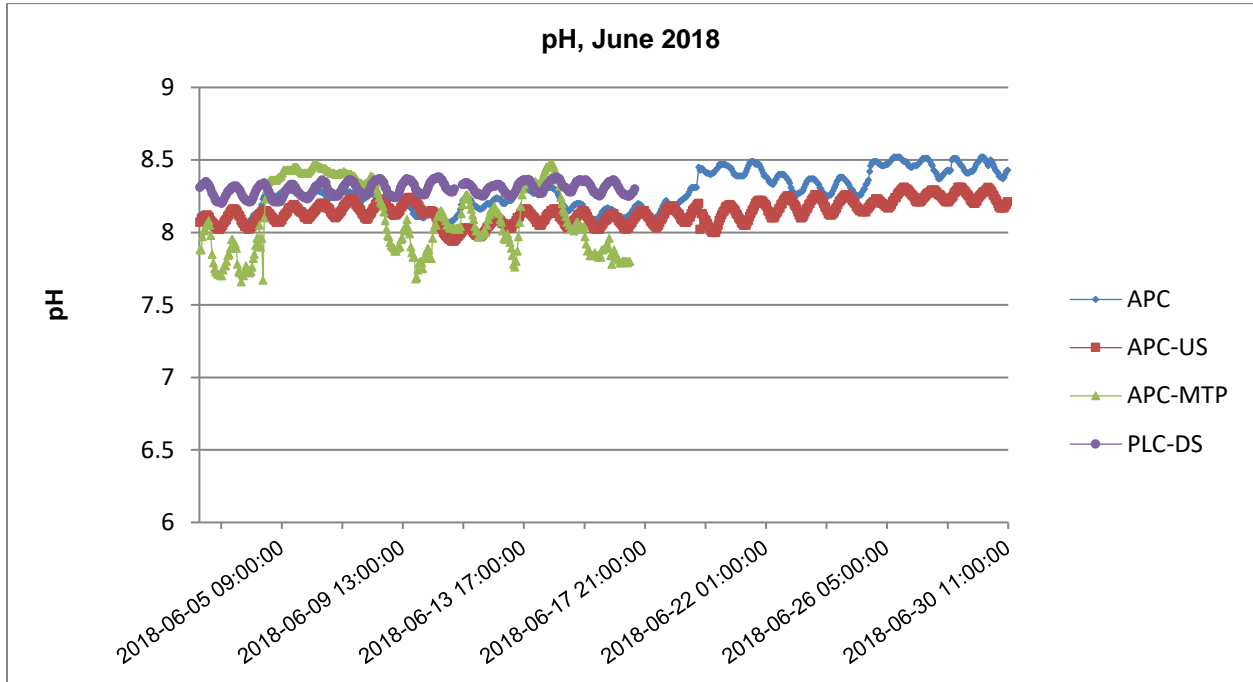
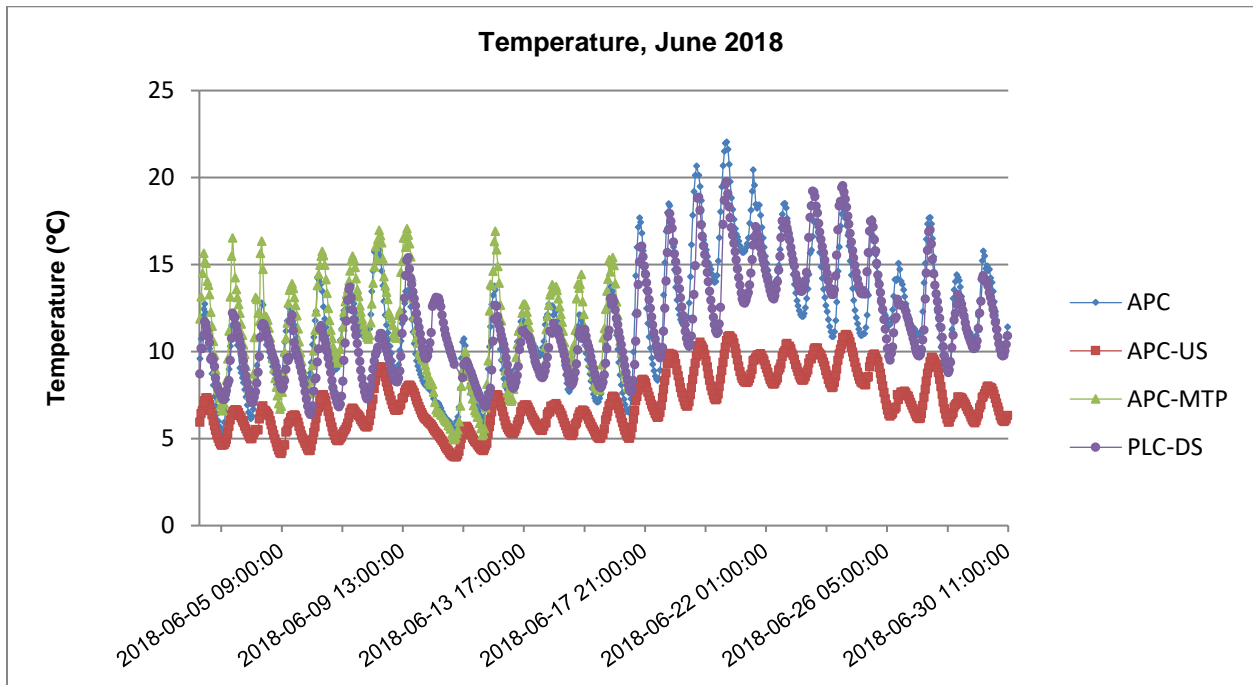
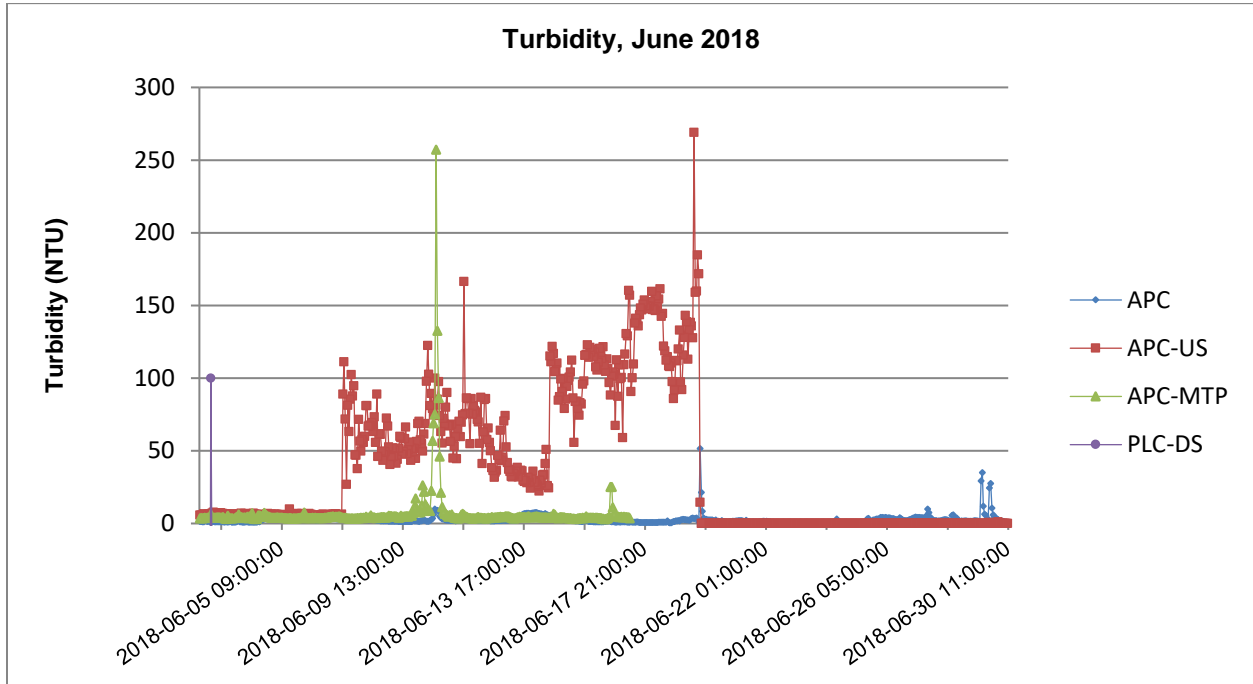
Appendix 1: June 2018 Data Sonde Data

- Appendix 1 - June 2018 Data Sonde Data
 - Please Note: data in monthly graphs are raw, uncorrected data. All data will be corrected applying standard correction methods using calibration records, field notes and water levels, data grading, and will be presented in the annual monitoring report.

Note: the data at APC-MTP ends mid-month as flow through the channel dropped significantly, to the point that measuring in-situ data was no longer possible. Also, some issues with PLC turbidity and pH readings are apparent and are related to a malfunctioning sensor. New sensors have been ordered to replace the faulty equipment and these will be swapped out once the new ones arrive.
