Westmoreland Coal Company
CVRI - Obed Mountain Mine

**RE: Obed Mountain Mine – Solids Recovery Project
Phase 2 Monitoring and Response Plan**

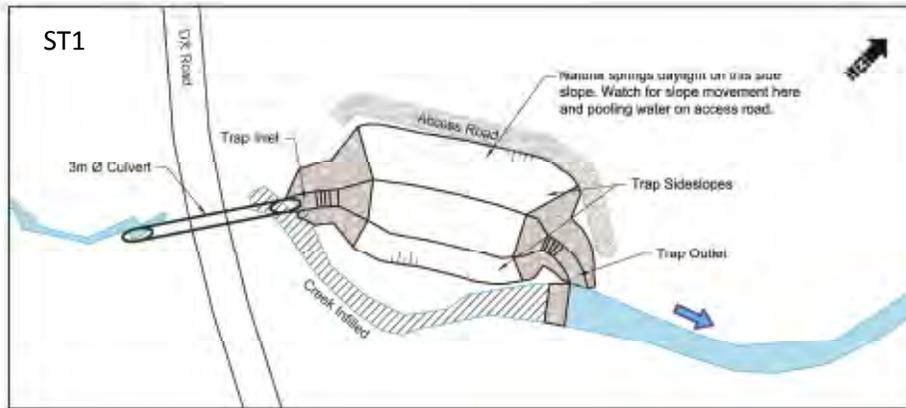
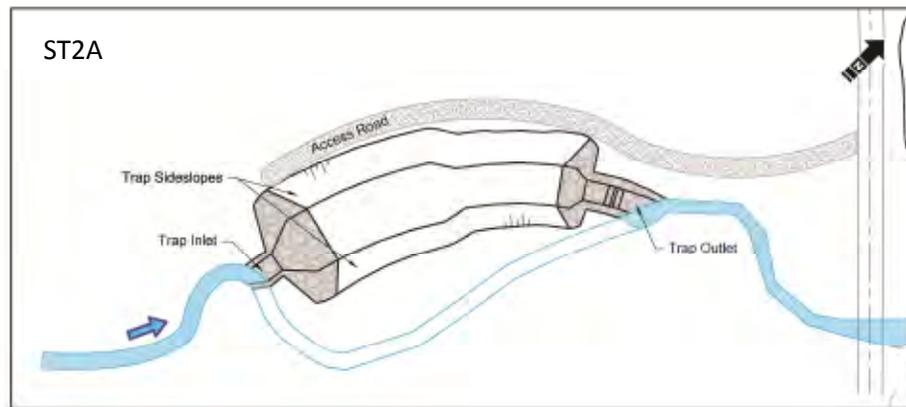
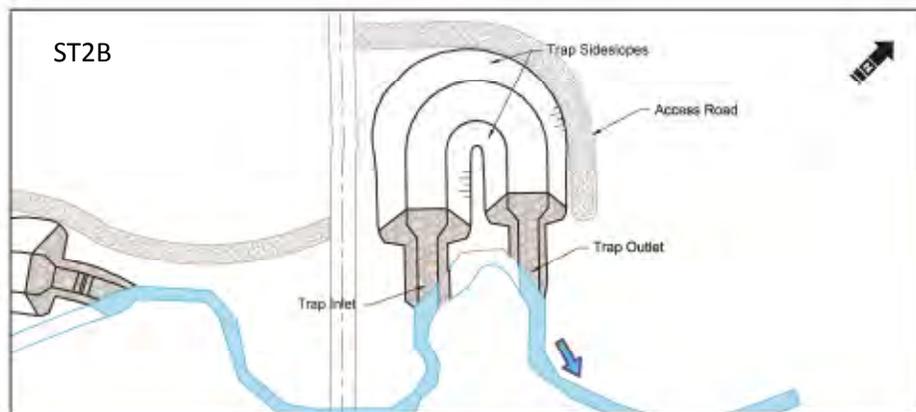
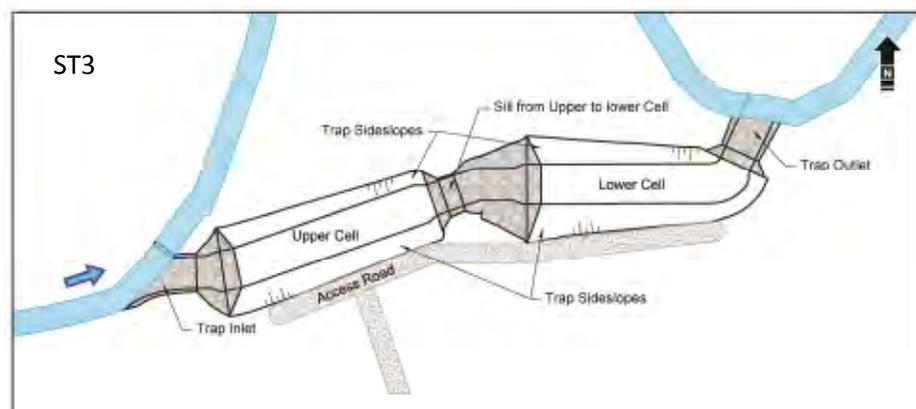
Method of Removal (vacuum/excavator/other)	
Describe the sediment accumulation (location in trap/approx. depth). Use sketches on reverse side.	
Issues (equipment access, plugged intake hose, etc.)	
Sediment Volume Removed (m ³) and TSS value (to calculate % water and % sediment)	
Lab particle size analysis

All Traps: Use vacuum trucks to remove sediment from the trap. This should not cause elevated turbidity levels in the trap. The sediment will be hauled to the disposal area which is currently the Red Pit at the mine. The volume of solids and deposition patterns that are removed will be tracked below.
