COAL VALLEY RESOURCES INC. – *Obed Mountain Mine*
 A Subsidiary of WESTMORELAND COAL COMPANY

Weekly Update Report : November 13th – November 19th , 2014

Prepared on: November 19th, 2014 Prepared by: Kari McDonald

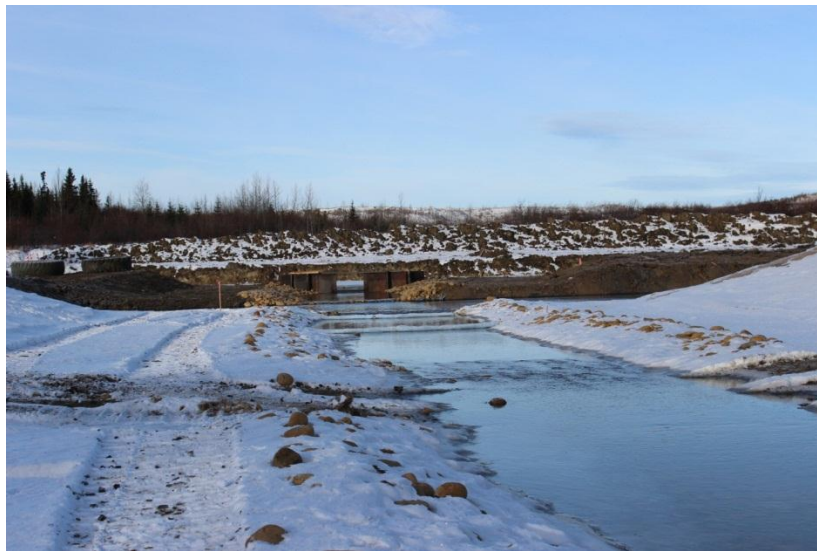
Main Tailings Pond Spillway with flow, Rectangular Weir in Background

- Levelling in Silver Pit
- Main Tailings Pond Spillway rebuilt, wier installed and water flowing clean out of Main Tailings Pond.

- Spillway designed to convey 1:1000 storm with 1 meter of freeboard on the Main Tailings Pond Dam
- Spillway allows for water quality management by installation of rectangular wier while still fulfilling requirements of freeboard for the dam
- Photos of completed spillway below
- Green Pit Spillway work has commenced
- ECP Completed, Photos below
- Main Office personnel moved into Main Shop, sign in is now at Main Shop
- Mine is in frozen conditions with minimal flows

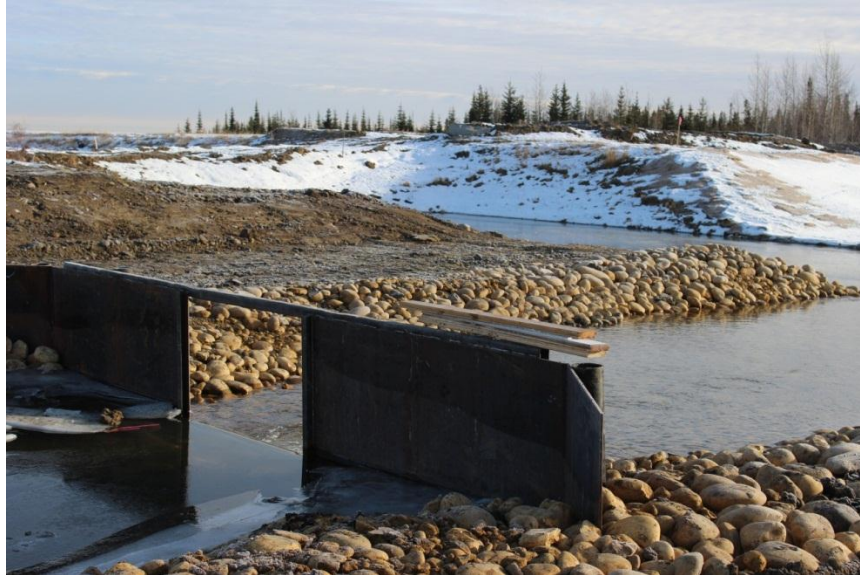
Main Tailings Pond Weir with Boards Removed and Clean Discharge

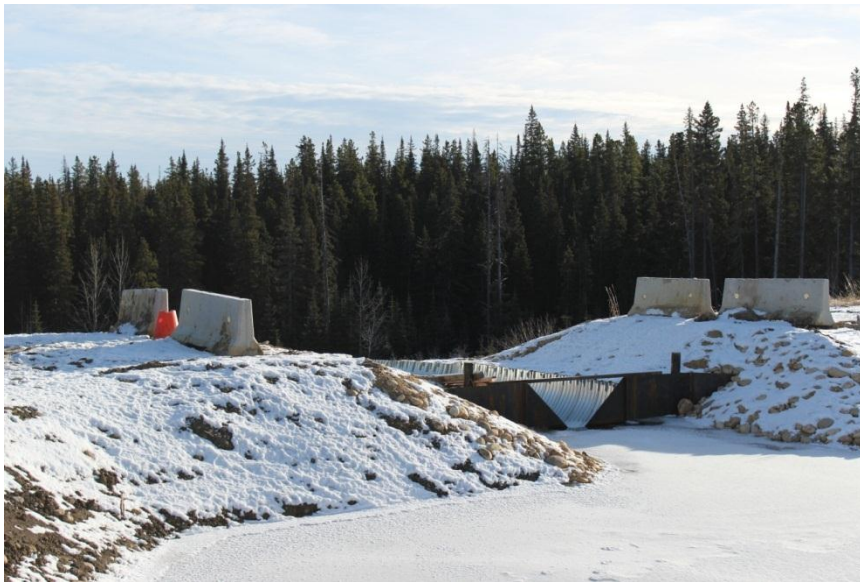
Completed ECP Weir and Culvert Repair: Installation of ½ Round Culvert
